Investigation of Structural Failure of a RC Hotel under Construction

Dr. Akil Ahmed, Prof. Mehtab Alam, and Dr. Asif Husain

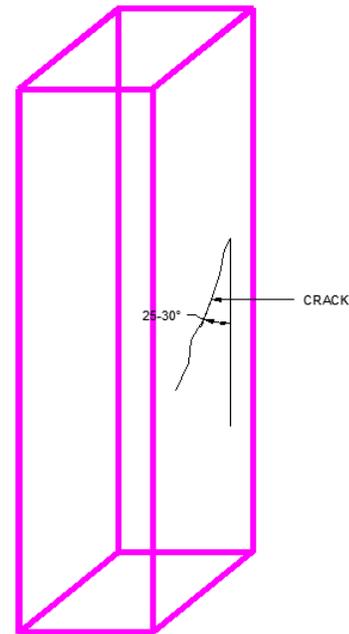
Fig.1 Type of cracks in the structure

As per the site condition, the following type of crack can be seen in the failed columns. After seen these cracks, it is clear that these cracks are mainly due to excessive shear produced by lateral earth pressure (Fig. 1).

1. The causes of the crack/damage were varying lateral earth pressure, ground water pressure, and poor grade of concrete. The lateral reinforcement was not adequate in the columns.
2. The cracks/damage to the structure had left it unsafe.
3. The quality of construction used was not as per standards and process of construction was not supervised by qualified and trained engineers.
4. Mix for M-20 grade of concrete is not as per IS 456:2000 recommendations. Other mixes i.e. M25 and M30 were okay.
5. A bit inferior quality of concrete and poor quality of shuttering used.
6. Coarse and fine aggregate were not available on the site for investigation.
7. The structural design needs to be revised for a high rise structure/building. The damaged components have to be repaired/retrofitted/re-casted depending upon the degree of damage.

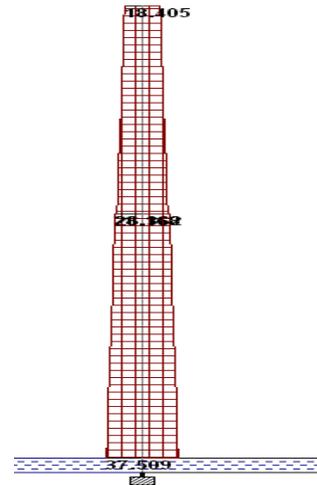
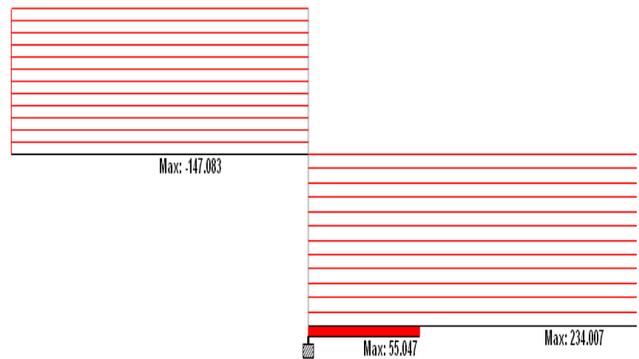
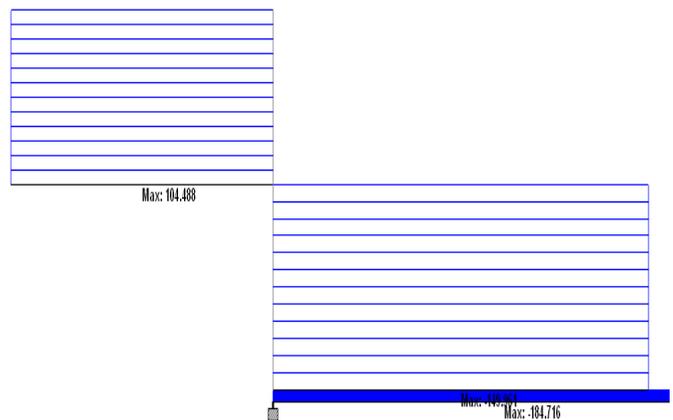
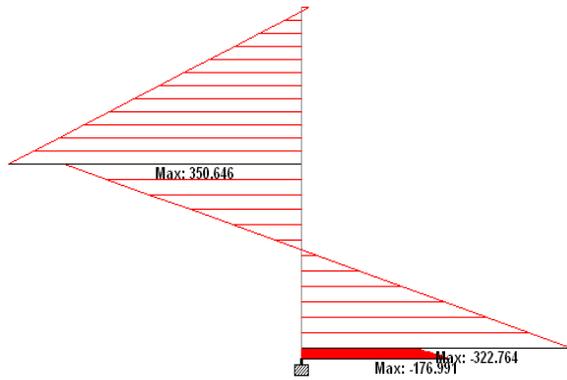
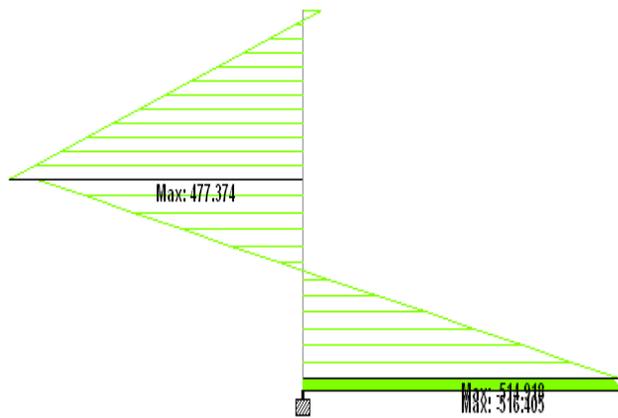
*Column N-3 (800*800mm):*

Some of the outputs of STAAD PRO for a column has been given below as a sample example (Figs. 7 - 11):

$V_u = 234.007$ Mton, Ultimate Shear Force

$\tau_v = 3.6$ MPa

$\tau_{c, max} = 3.5$ MPa < 3.6 MPa

Section is not Safe

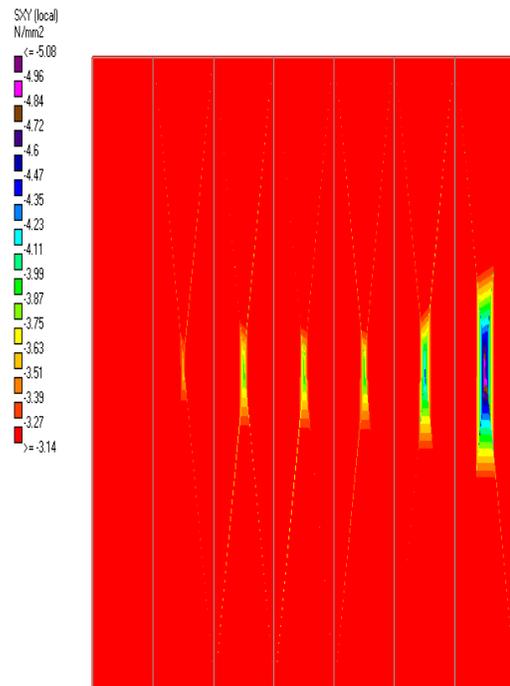
Fig.12 Shear stresses

Shear wall at H-14 (300 mm Thick):

Maximum shear stress (Fig. 12) in the shear wall is 4.84 MPa > $\tau_{c, max} = 3.5$ MPa. Therefore, the shear wall section is unsafe.
