Building Design Failure. Why Did It Fail? How It Could have been Avoided?

Abstract—The purpose of the paper is to share the findings on the typical problems facing the buildings in term of the problem leading to building leakage scenario in Malaysia. The paper tabulate list of potential solutions best practiced by the local waterproofing implementer with data on real case studies pertaining to the building leakage typically happened from roof as well as the toilet or cracked building expansion structures. The case studies are derived from the real selected projects done by the associated building maintenance contractor for the last 20 years. By identifying the possible factors that cause the leakages, one can take early steps to prevent the same defects from repeating thus saves on the financial side. The finding indicates the formulation ideas that can be used for creating a framework in preventing or minimizes the building leakage syndrome from happening again. The analysis from this paper may give some meaningful tabulation on how to maintain these standard buildings from leaking especially from the roof seepage thus make the property much more valuable to the owner.

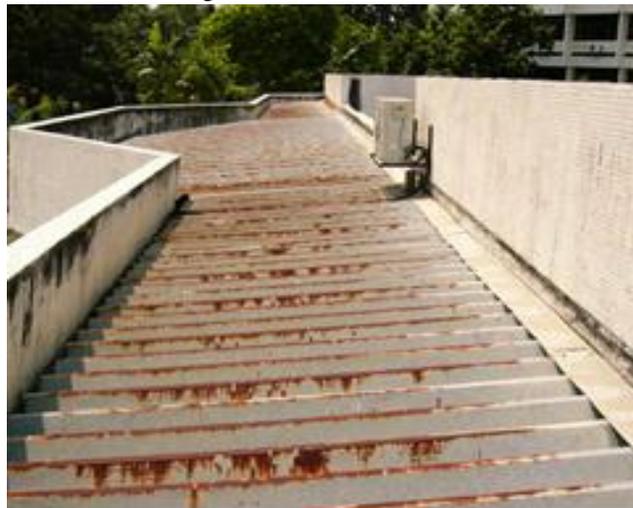
Why did it fail? Metal roofing will show the rust failure after quite some time due the rain and shine due to harsh tropical weather. How it could have been avoided? To rectify this rusty problem –

2. Certain part of the roof may have holes on it need to be treated to ensure not leaking. Special treatment using water proofing coating and fiber-matte can solve the hole on metal problem. As expected the holes appear because of metal failure due to rusting

Fig. 1 The existing metal roof showing the rusty appearance and having several spots with holes allowing rain water penetrate towards the inside of the building

1. The metal surfaces need to be treated with water proofing and rust proof special paint to ensure the same metal roofing material can still be used and no need to be replaced.

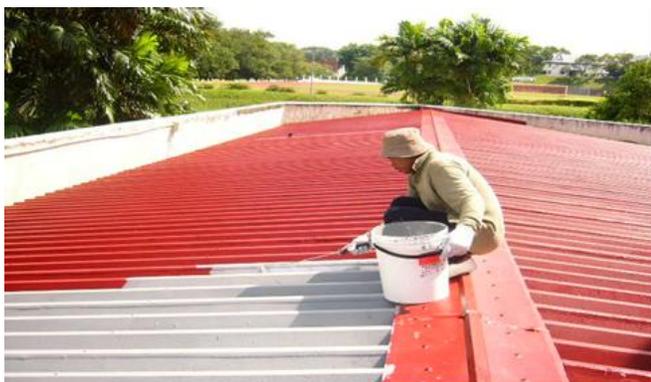
Fig. 2 Rectification work done by applying layers of waterproofing coating on top the metal surfaces

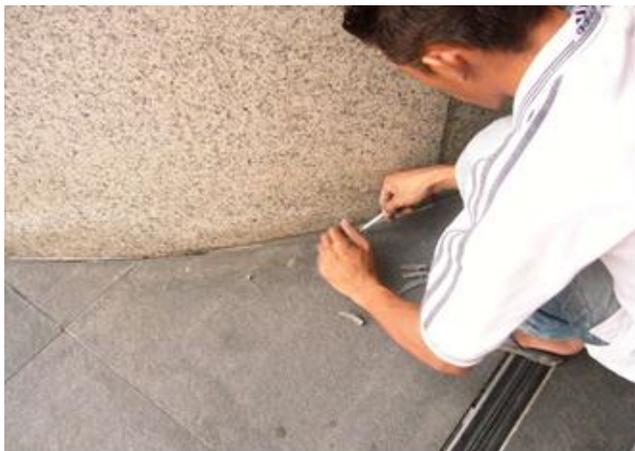
Why did it fail? The typical problem joining two materials of the floor and wall/column is the silicone sealant not functioning due to time and weather. Failure to replace the dead silicone/epoxy may result in building leakage. How it could have been avoided? To rectify this from happening -

Fig.3 Applying new sealant epoxy must be done in a hot day for best result

1. The only solution is to replace with the new building construction sealant.
2. Ensure using the silicone with high quality endorsement for better and longer time performance.
3. It is best to apply the new sealant during the hot day for better result.

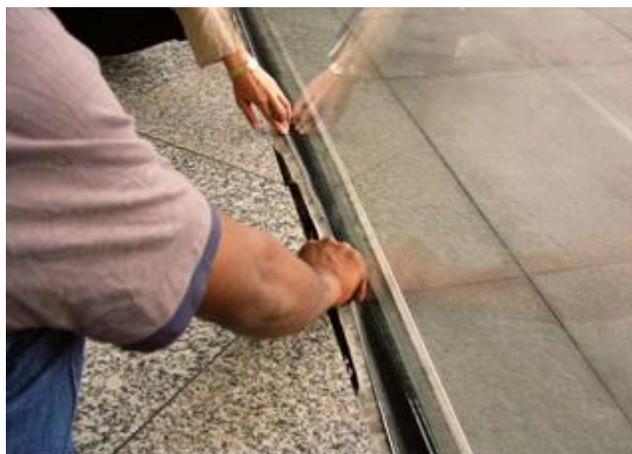
Why did it fail? When the time comes, the building sealant applied between the indoor and outdoor spaces such between the glasses walls with fully air-conditioning 24 hours may deteriorates and become as hard as stone. How it could have been avoided? To rectify this from happening-

Fig. 4 Expired sealant located in the internal side of the building with cracks appearance

1. The only solution to take out the old sealant and replace with the new silicone.
2. Due to the area with high traffic most of the time, the new sealants replacement must be done during the less traffic time to ensure nobody spoil-up the flaccid epoxy.

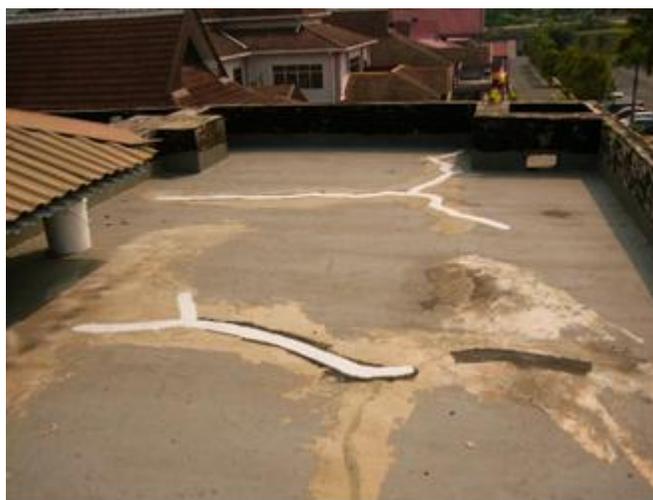
Why did it fail? Most of the problem with building having flat roof is the cracks on the surface of its flat concrete part thus permit the water penetrates through the inner part of the building. This may cause serious damage on its internal parts such as it furniture, equipment etc. How it could have been avoided? To rectify this crack from happening-

Fig. 5 Concrete flat roof having long cracks line being rectified to ensure rain water do nor seeping through the weak lines

1. To do the water-proofing treatment by using proper material to treat the cracks.
2. Normally, the crack lines been treated with water proofing cementitious paint like material been applied.
3. High quality cotton fiber and silicone epoxy also may be applied if the cut quite deep.
4. If the cracks appear at the most of the concrete surface area; the coating type water proofing liquid membrane need to be applied with several layer. Apply first layer with asphalt to ensure correct liquid membrane thickness achieved.
5. Again, the best condition is doing this rectification works during the hot weather

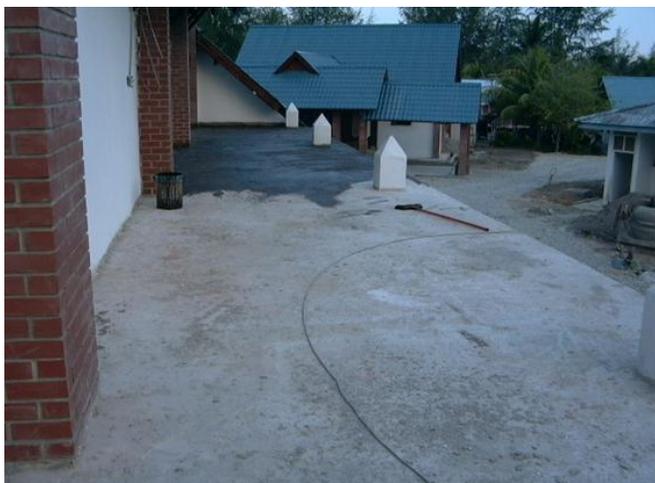
Why did it fail? Most of the building having the side of the building with concrete flat top designed for its verandah walkway roof cover. There is always the builder left over this roof part with no proper water proofing thus creating leakage problem. How it could have been avoided? To rectify this from happening-

Fig. 6 The building originally has not been water proofed and task been taken to rectify this using asphalt type material over bare concrete flat slab

1. Problem may be solved if the designer goes for the pitch roof design to cover this walkway.

2. However, if the client still prefers the flat top concrete, please ensure proper water proofing treatment has been done before accepting the handover.

3. This photo shows the asphalt type of leak free material has been applied on its bare concrete surface.

4. Asphalt type of leaking liquid membrane with proved performance like ATLAS-COTE brand© may be a good choice for its good performance due to the harsh tropical climate.

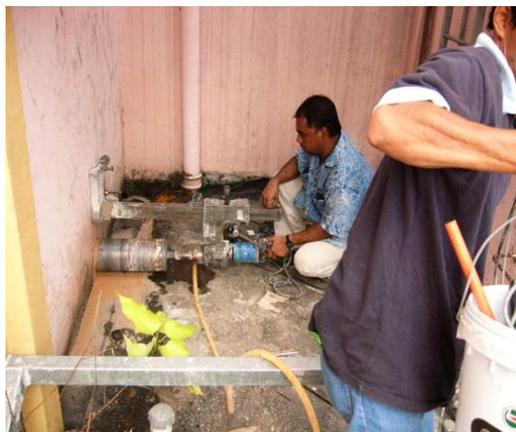
This is the problem where the size of the Rain Water Down Pipe (RWDP) pipe size is too small to cater the amount of rain water (see Fig. 7). Thus, this photo shows the process of making another hole to install another RWDP. How it could have been avoided? To rectify this from happening-

3. Failure of this part may result in over flow of rainwater and water penetration through the internal part of the building. This will surely damage the interior of the structure.

Fig. 7 The process of cutting the concrete wall slab to allow in making bigger RWDP

1. To ensure that the architect/designer to consider having use bigger size of RWDP to cater the amount of rain water.

2. The bigger surface of roof top with the flat concrete roof may need bigger and more numbers of RWDP.

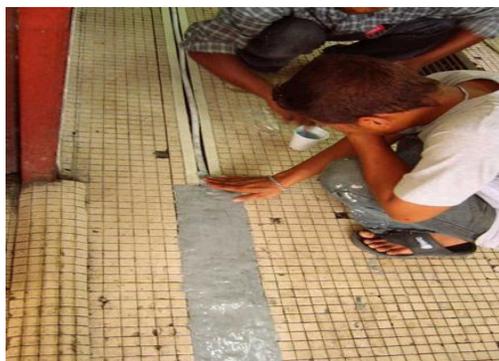
Why did it fail? This defect happens when the sealant joint between two parts of the building failed (see Fig. 8). The failed part always let the water to penetrate through and allow cracks to appear. How it could have been avoided? To rectify this problem from happening-

Fig. 8 The process of installing new building joint sealant after removing the expired epoxy

1. To replace the old epoxy sealant with the new one.
2. Please ensure you take off the old non-functional sealant completely and clean-up the surface from foreign objects.
3. Due to the hot tropical climate, the stretching and shrinking of the concrete require maintaining this joint sealant in due time is important.

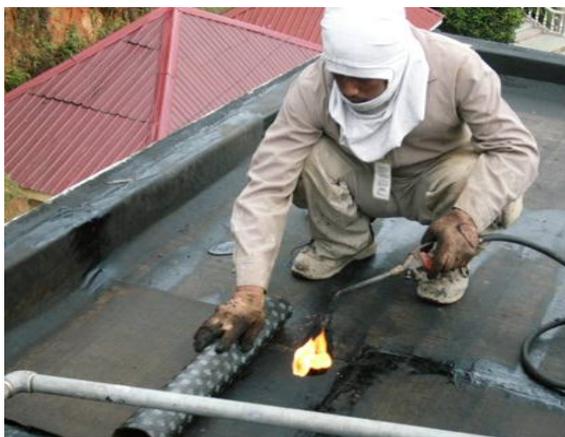
Why did it fail? Flat roof building always give the charmed geometrical iconic shape form the observer. However, having tropical climate require proper implementation to cover its bare flat concrete surface. This photo shows the process of torching the hard water proofing membrane been applied to cover the top. Improper membrane installation always allows water to seep through and create problems. How it could have been avoided? To rectify this thing from happening-

Fig. 9 The process of torching the hard membrane on top of the concrete flat roof taking place

1. To ensure the joint between the membrane sheet overlapping gap having minimum 50mm lap to minimize water seepage.

2. Also to ensure the torching heat been applied evenly to let the membrane bottom glued well on top concrete surface.

3. Proper cleaning of the concrete surface before the membrane application had been done.

4. Please ensure the water proofing membrane having the skirting up to the building beam edge to defer water seeping as seen on this photo.

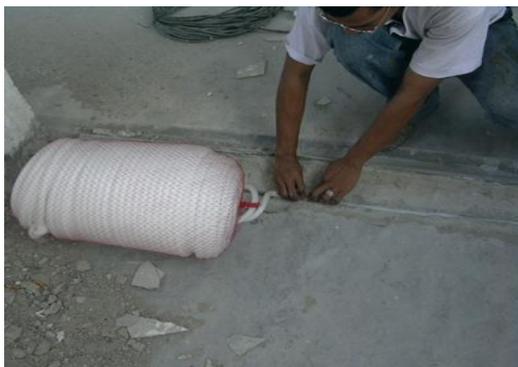
Why did it fail? For bigger building complex, the phase construction technique allows certain part of the building having long lines of building construction joints lines. With no proper installation of backer rod roll may give water penetration hence create leakage problem. At this case, the leaking water will fall into the parked vehicle. How it could have been avoided? To rectify this problem from happening-

Fig. 10 Putting the white color backer rod between the building joint or crack

1. Ensure proper installation of high grade building joint backer rod roll between the gaps.
2. Most of the failure is when the contractor left over the installation of the joint by simply render the joint with concrete.
3. With no proper fiber joint installed will let cracks appear right after handing over.

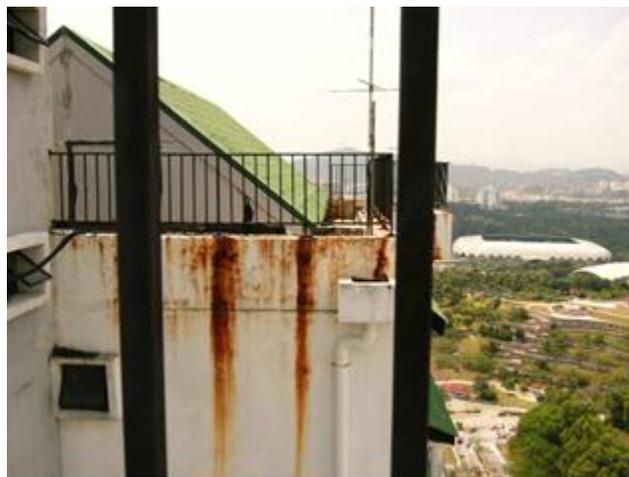
Why did it fail? In this case, the building manager decided to install steel fence on top of flat roof raised edge for safety reason. However, through times, the metal reaction to weather letting ugly rust stained appear clearly on the white paint wall surface.

Fig. 11 The rusty defects appear on top of the bright color paint at one of the condominium building near Kuala Lumpur

1. Ensure to paint the metal surface with anti-rust paint material.

2. Also to ensure the metal screws using to hold the fence need to use from stainless steel type to avoid rust building.

3. The metal fence may need not to be erected if the maintenance crew using the safety belt equipment while doing routine maintenance works at this building edge.

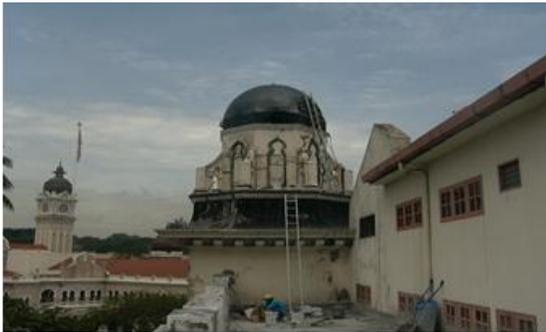
Why did it fail? Most of the concrete dome has been built by the colonial British copying the construction technique over in ruled India. However, to keep these domes in good shape require great care due to the Malaysian humid and hot climate (see Fig. 12). For this case, the concrete dome let many cracks appear on its surface thus letting the rain water seep into the concrete. At one point, the water reacts with concrete ingredient hence posing the leakage problem for the interior. How it could have been avoided? To rectify this leakage from happening-

Fig. 12 The process in doing the rectification of this heritage building involving different sizes of concrete dome

1. Ensure proper water proofing rectification done in right sequence and right material being used.
2. All the crack lines must be treated first with leak proof material.
3. For this case, the first waterproofing layer to be covered on the dome surface is using asphalt type of material.
4. The next and final layers are suggested to use high grade cementitious liquid membrane to be applied.
5. Recommended this exercise during hot sunny day for better material absorption into the old concrete.

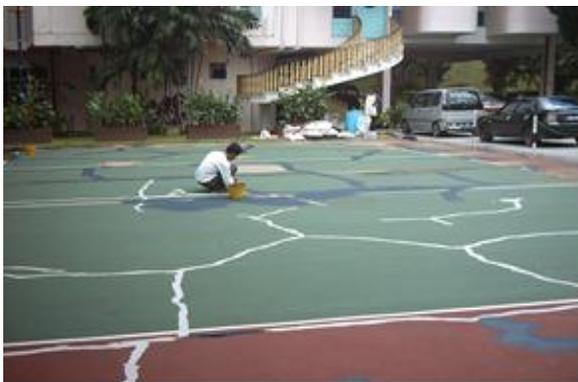
Why did it fail? Typical cracks appear on the surface of the play court hence interrupt the smooth usage of the course. The cracks also give not nice appearance looking from the distance. Late treatment may result into bigger and deeper holes appear on the crack (see Fig. 13).

Fig. 13 This play court require treatment to every single cracked lines before the whole coating being applied

1. Ensure to do the correct treatment along the crack lines first before redo the court surface rectification.

2. Next to lay-out or paint-off all the court surfaces with right heavy-duty sport surface coating paint with correct thickness. When applying too thin or too thick of the coating may developed problem (hairline cracks). So, experience personnel dealing with this kind of work need to be find.

3. The cracks can totally being avoided if the builder use correct and right concrete installation process for the play court.
