Investigation of Structural Failure of a RC Hotel under Construction

Dr. Akil Ahmed, Prof. Mehtab Alam, and Dr. Asif Husain

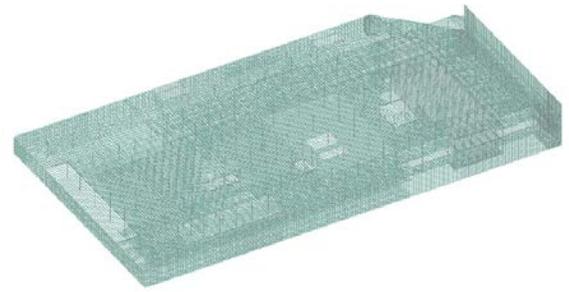
The modelling of the structure had been done in STAAD-Pro. The beam and column of the structure were modelled as member element whereas the slab and walls were modelled as plate element (Fig. 2).

Fig. 2 3D-model of the hotel in STAAD-Pro

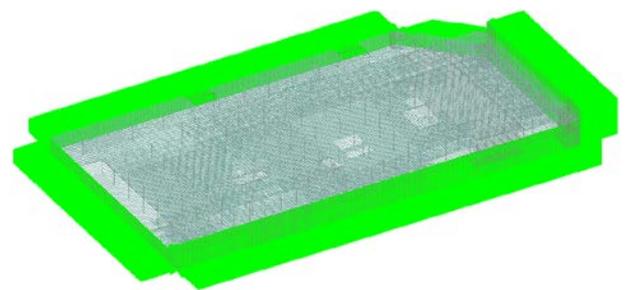
The earth pressure applied on the retaining wall was as per the site condition (Fig. 3). It is worth noting that the height of the retaining wall was not the same on all the five sides, rather varying on the three consecutive sides while almost equal on the remaining two sides.

- Calculation of K_a
 $K_a = (1 - \sin\alpha) / (1 + \sin\alpha) = 1/3$
- Maximum horizontal pressure for 4.5 m height from top having soil density of 1.80 Mton/m^2
 $= y * H * K_a = 2.70 \text{ Mton/m}^2$
- Maximum horizontal pressure for remaining 6 m height having saturated density of 1.78 Mton/m^2
 $= y_s * H * K_a = 0.78 \text{ Mton/m}^2$

Fig. 3 Earth pressure applied on wall

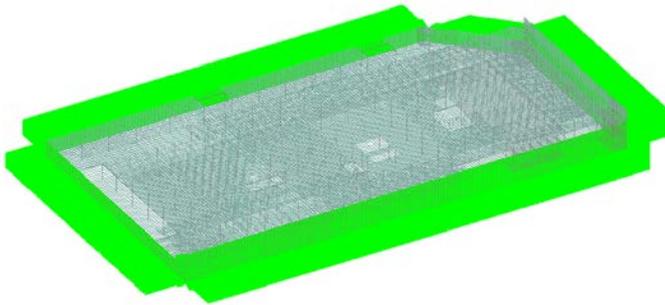
The water pressure applied on the retaining wall is as per the site condition (Fig. 4). That means wherever whatever the earth pressure has been observed during the site visit is modelled in the structure.

Fig. 4 Water pressure applied on wall

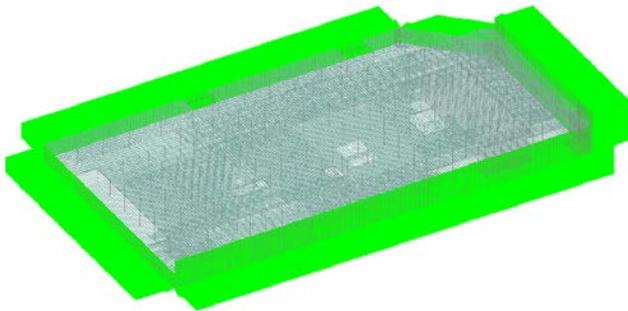
The surcharge applied on the retaining wall was as per the site condition (Fig. 5). That means wherever whatever the earth pressure has been observed during the site visit was modelled in the structure.

Fig. 5 Surcharge

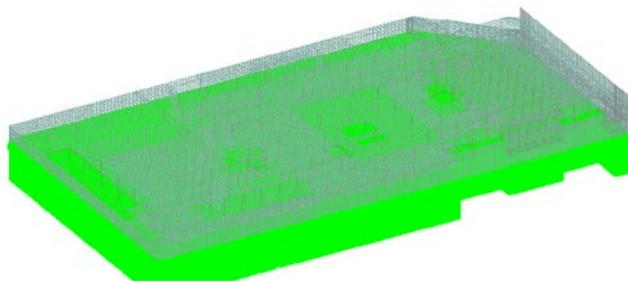
Soil pressure according to the self weight of existing structure and water pressure of 6.5 Mton/m² had been applied on the raft from below (Fig. 6).

Fig. 6 Water and soil pressure from below
