Building Design Failure. Why Did It Fail? How It Could have been Avoided?

Abstract—The purpose of the paper is to share the findings on the typical problems facing the buildings in term of the problem leading to building leakage scenario in Malaysia. The paper tabulate list of potential solutions best practiced by the local waterproofing implementer with data on real case studies pertaining to the building leakage typically happened from roof as well as the toilet or cracked building expansion structures. The case studies are derived from the real selected projects done by the associated building maintenance contractor for the last 20 years. By identifying the possible factors that cause the leakages, one can take early steps to prevent the same defects from repeating thus saves on the financial side. The finding indicates the formulation ideas that can be used for creating a framework in preventing or minimizes the building leakage syndrome from happening again. The analysis from this paper may give some meaningful tabulation on how to maintain these standard buildings from leaking especially from the roof seepage thus make the property much more valuable to the owner.

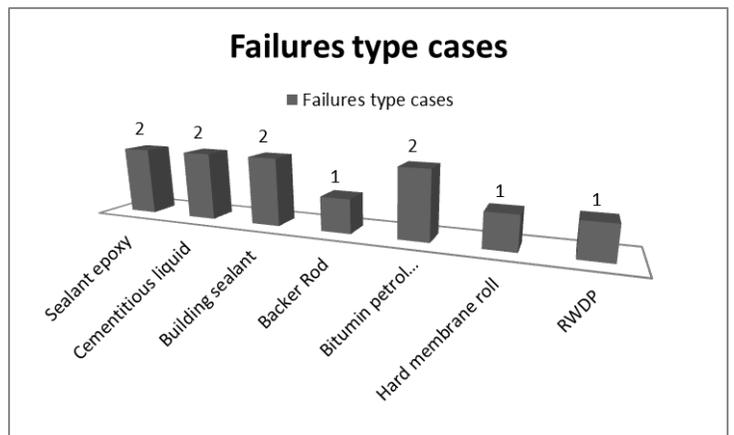
Fig. 14 It shows the typical building failures type cases found from the study such as the use of bitumen petrol based coating being applied for rectification works to enlarging holes to fit bigger RWDP

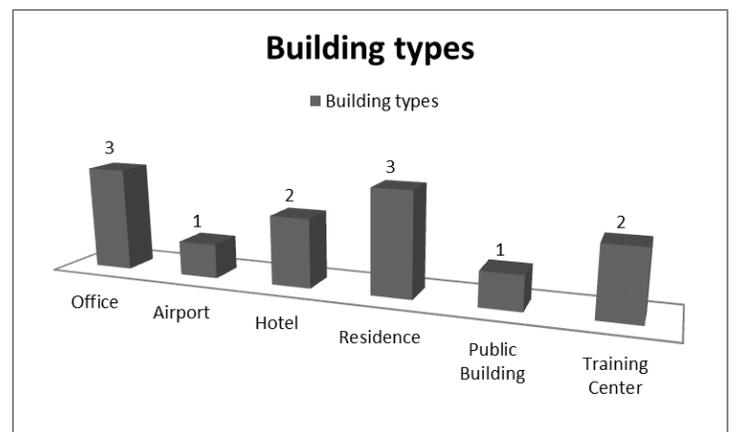
Fig. 15 The graph shows the types of building being categorized for segregation. Residential housing and office buildings are more common for the cases

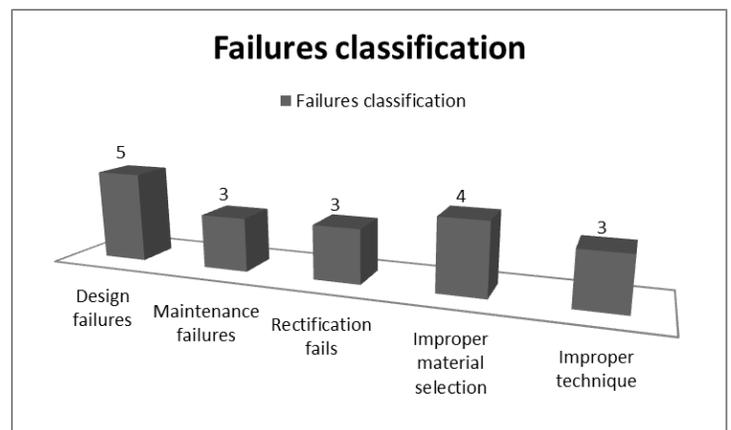
Fig. 16 The above chart states most of building failures started from the drafting table which are involved during design stage. The other 4 building failures can be categorized from maintenance problem, low quality rectification works, improper rectification material selection and wrong reparative technique
