# Friction Measurements in Restaurants Kitchens

**Abstract**—Slip & fall are major occupational safety & health incidences. This research was conducted for floor friction coefficient measurements in four restaurants in each of Chinese, western, and western style fast food restaurants. Walkway, sink, and cooking areas for each of the restaurants were selected and 8 points on the floor in each of the area were measured. A Brungraber Mark II friction measurement device was used. A Neolite standard footwear pad was attached to bottom of the strut of the BM II. The friction coefficient measurements results indicated that Chinese style restaurants had significant lower averages and high variation in friction coefficient. The western style restaurants had also significantly lower floor COF than those of the western fast food restaurants. This implies such floor environments had high risk of slip & fall. The slip resistances of the kitchen floors in the visited restaurants were discussed.

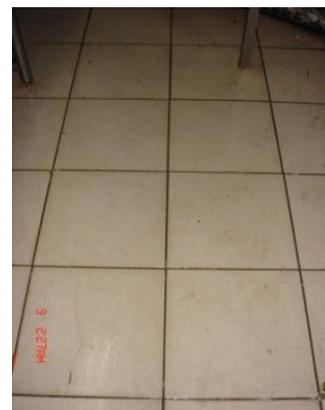
Fig.1 Ceramic tile of Chinese restaurant A

Three types of restaurants were selected: Chinese (CR), Western (WR), and western fast food (WF) restaurant. Four restaurants for each of the type were selected. This comprised 12 restaurants in total. The kitchen floor environments were inspected before the study began. Each of the type of the restaurants was term as A, B, C, and D. Each restaurant may be termed using the type and a letter. For example, WR-C means Chinese restaurant C. The floors in the kitchen of both CR-A (see Fig. 1) and CR-D were ceramic tiles. The floors in CR-B (see Fig. 2) and CR-C were cement and epoxy resin (see Fig. 3), respectively. For all the four western restaurants, the kitchen floors use similar ceramics titles (see Fig 4). The four western restaurants belong to the same chain stores. They used the same type of quarry tiles (see Fig. 5). All the kitchens in restaurants have drenches covered with steel covers.

The means, standard deviations, and coefficients of variation (CV) of the COF for each area in the Chinese restaurant were shown in Table II. In Chinese restaurant A, all the floors were wet when the friction measurements were conducted because the kitchen workers had just finished cleaning the floor by spraying fountain water on the floor. Most of the COF measured in this restaurant was approximately 0. The concrete floor in Chinese restaurant B had pretty good slip resistance. Most of the COF values obtained in the kitchen of this restaurant were well above 0.5, a standard commonly adopted in the USA.

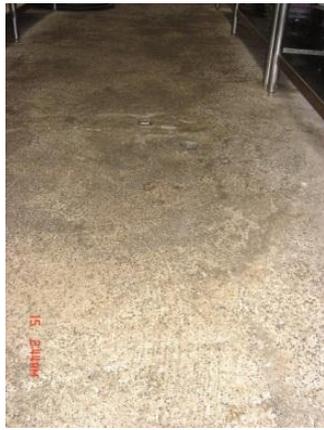
Fig. 2 Concrete floor of Chinese restaurant B

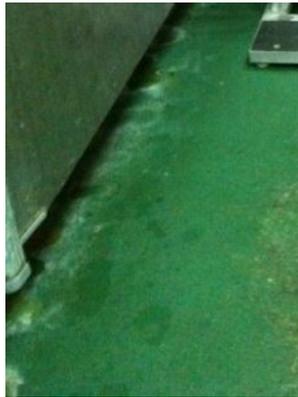
Fig. 3 Epoxy floor of Chinese restaurant C

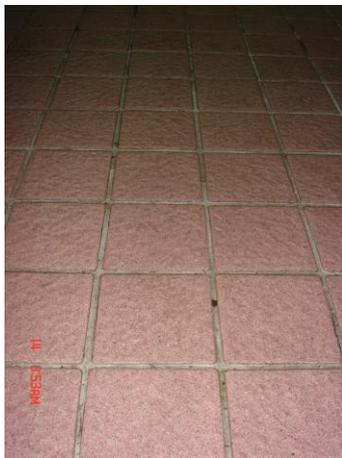
Fig. 4 Ceramic floor of western restaurants

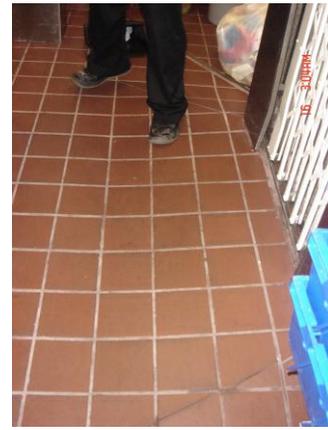
Fig. 5 Quarry tile of western fast food restaurant

Tile was found a significant factor affecting the COF of the floor. Cement floors normally provide high COF values. However, they were not common because of their appearance and housekeeping problems. Ceramic with glaze and epoxy resin generally resulted in low COF when covered by water or other liquids. Quarry tile without glaze especially when they have embedded emery on the surface is a good choice as this type of floors provide COF higher than 0.5, a standard recommended by the ANSI 1264.

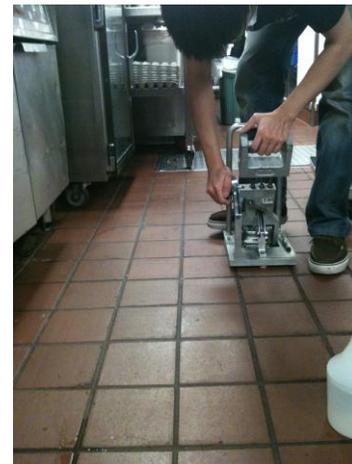
Friction measurements were performed using a Brungraber Mark II (BMII) slipmeter (see Fig. 6). Standard Neolite footwear pad was adopted. Operations of the BM II follow the recommendations in the American Society for Testing and Materials (ASTM) F-1677-05 [11] and Chang [12]. The data collected were the coefficient of friction (COF).

Fig. 6 Friction measurements using the BM II in The kitchen of a Chinese restaurant
